M27 Southampton Junction 8  
Highways England  
Stage 2 Road Safety Audit

Document reference: HE551514-SWE-HGN-  
ZZ-RP-ZZ-50001

## Report Title                    Stage 2 Road Safety Audit

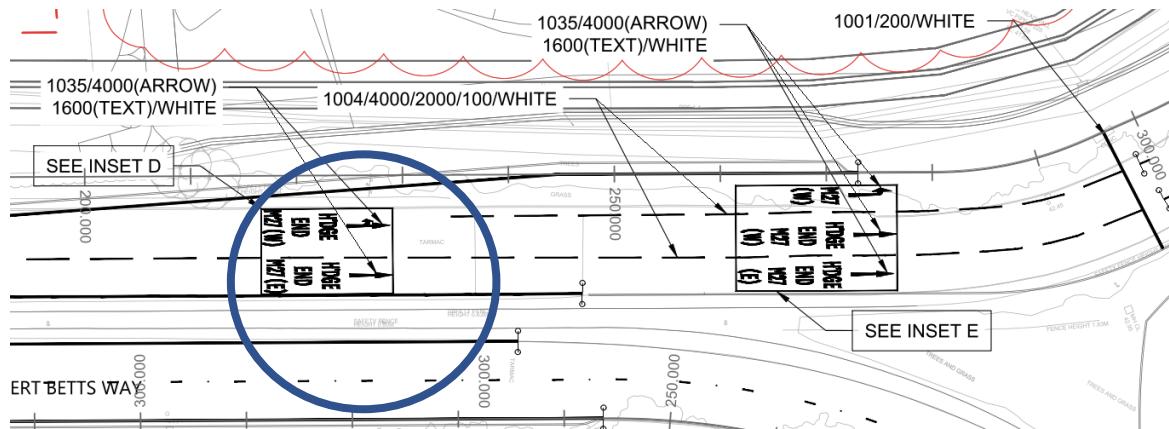
**Figure 4.1: Carriageway Text Markings**

On the eastbound approach to the M27 junction 8 roundabout on Bert Betts Way, carriageway markings indicate that lane 1 (on the two lane approach) support straight ahead, and left turn movements to Hedge End and the M27, Figure 4.1. As vehicles proceed eastwards towards the proposed traffic signals an additional 3<sup>rd</sup> lane is provided. The direction to Hedge End is marked as lane 2 & lane 3 only. There is a danger that if traffic is queuing back from the traffic signals that the text markings on the carriageway will be covered showing the three lane text markings. Unfamiliar drivers may therefore utilise lane 1 of the three lanes assuming this is the marked direction to Hedge End. As drivers approach closer to the circulatory any drivers positioned in lane 1 for Hedge End noting their incorrect lane selection, may attempt to select lane 2 therefore increasing the potential for side swipe type crashes.

It is recommended that a dedicated lane advance direction sign is included on the Bert Betts Way approach to the junction 8 roundabout circulatory to supplement the carriageway markings and to provide greater clarity of lane selection for route destination. Note Traffic Signs Sheet 2 of 5 drawing ref: HE551514-SWE-HSN-ZZ-DR-CH-50002 indicates sign ES2-08 on the eastbound approach to the traffic signals. This sign is not shown on the sign schedule, but it is assumed this sign is the map type sign showing the roundabout ahead with route directions (see Figure 4.2), and therefore does not fully aid drivers with lane selection.

For additional clarity, the removal of the road markings proposed in INSET D above, and replacement with an additional set of the proposed markings shown in INSET E may aid route finding. A similar approach on the westbound approach to Windhovor roundabout may also be adopted.

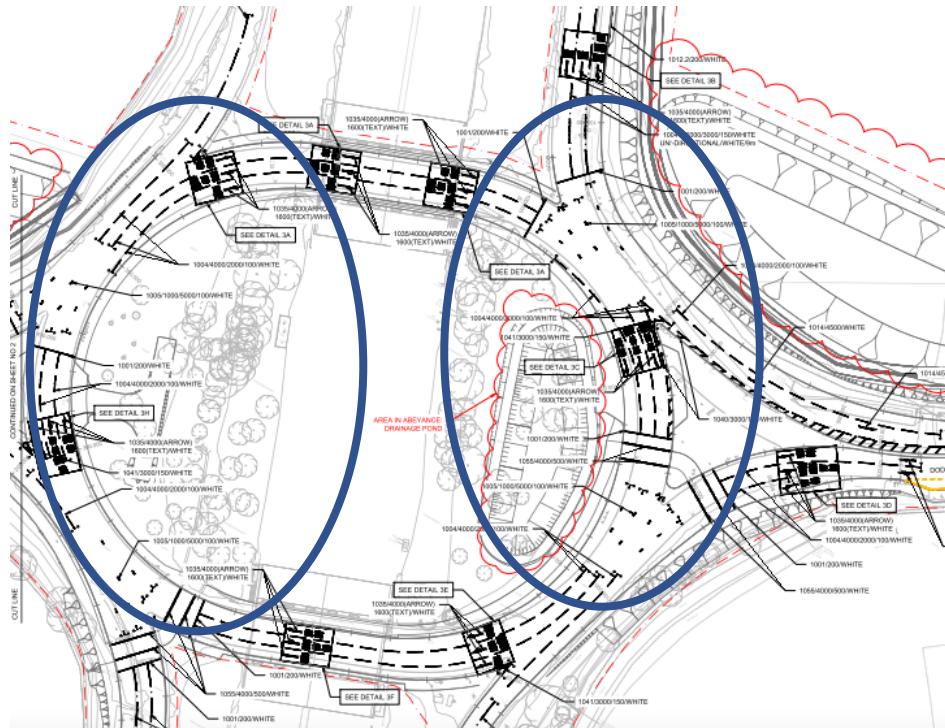
**Figure 4.3: Roundabout circulatory markings at Junction 8 M27**

The M27 Junction 8 roundabout circulatory proposes to utilise 1005 road markings to help guide road users to the appropriate lane and onward destination. Due to the variable number of entry and exit lanes from the roundabout arms compared to the number of circulatory lanes, there is a danger that the proposed road markings may not offer sufficient guidance to road users to enable them to naturally enter their desired receiving lane. This may result in driver hesitation and lead to an increased likelihood of side swipe type crashes.

It is recommended that full/improved spiral road markings are introduced on the roundabout circulatory and entering and receiving lanes to provide clear guidance to road users.

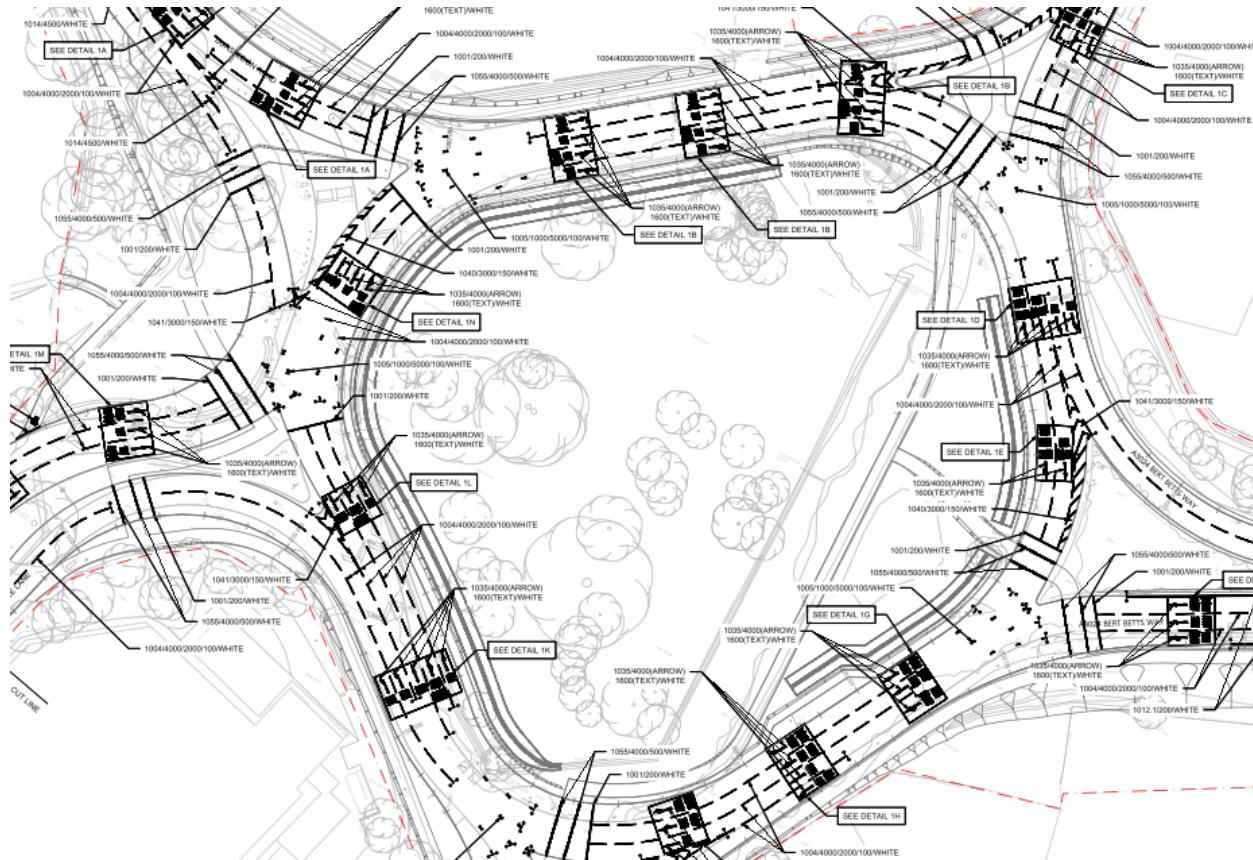
**Figure 4:4 Road markings proposed on Windhov roundabout**

Windover roundabout includes 5 arms (Figure 4.4). Each arm includes between 1 and 3 carriageway lanes in each direction to reflect traffic flow requirements. The roundabout circulatory also includes a variable lane balance to reflect the entry and exit traffic flows for each arm. Windhover roundabout therefore has a changing lane balance throughout the circulatory between 2 and 5 lanes. This changing lane balance, particularly for unfamiliar drivers, may result in difficulties in way-finding. This is most likely to pronounced when attempting to negotiate the area past the signal stop line on the roundabout circulatory where proposed guidance markings for circulating and turning vehicles provide limited information for road users. The absence of clear and concise information to drivers in terms of lane selection may result in driver hesitancy and potentially an increased likelihood of side swipe type crashes.

It is recommended that full / improved spiral road markings are introduced throughout the roundabout to aid way-finding.

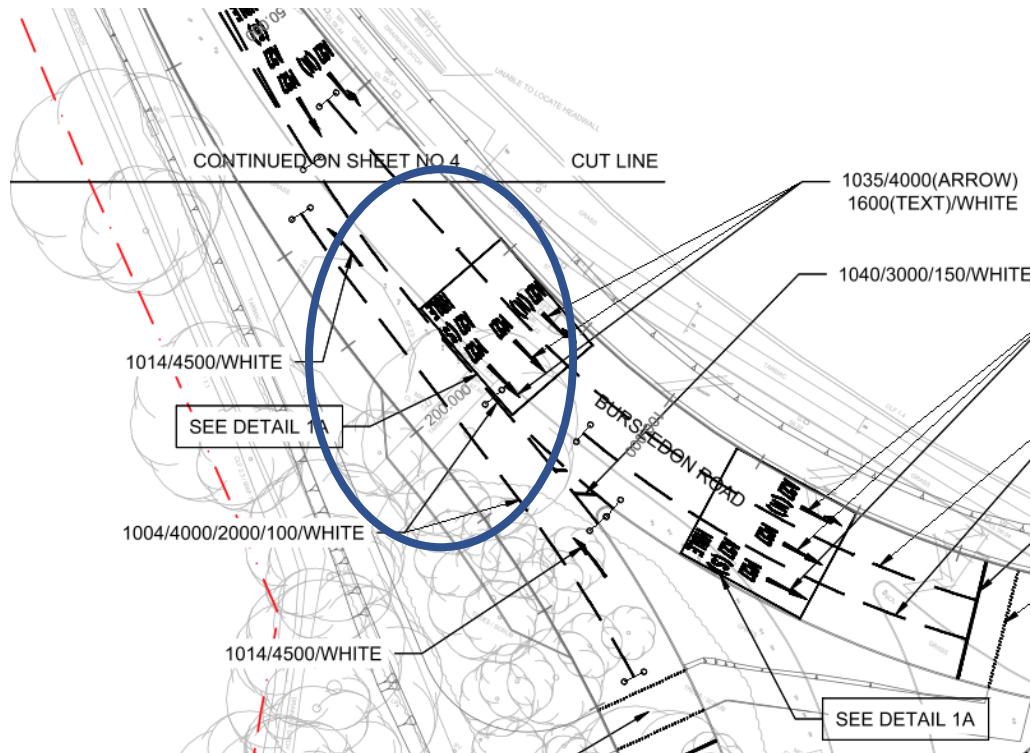
**Figure 4:5 Road marking showing the division of north and southbound movements.**

southbound vehicles may overrun the centre line at this location therefore potentially resulting in an increased likelihood of head-on type crashes.

It is recommended that the central hatching is extended from the splitter island to provide additional separation between north and southbound carriageways.

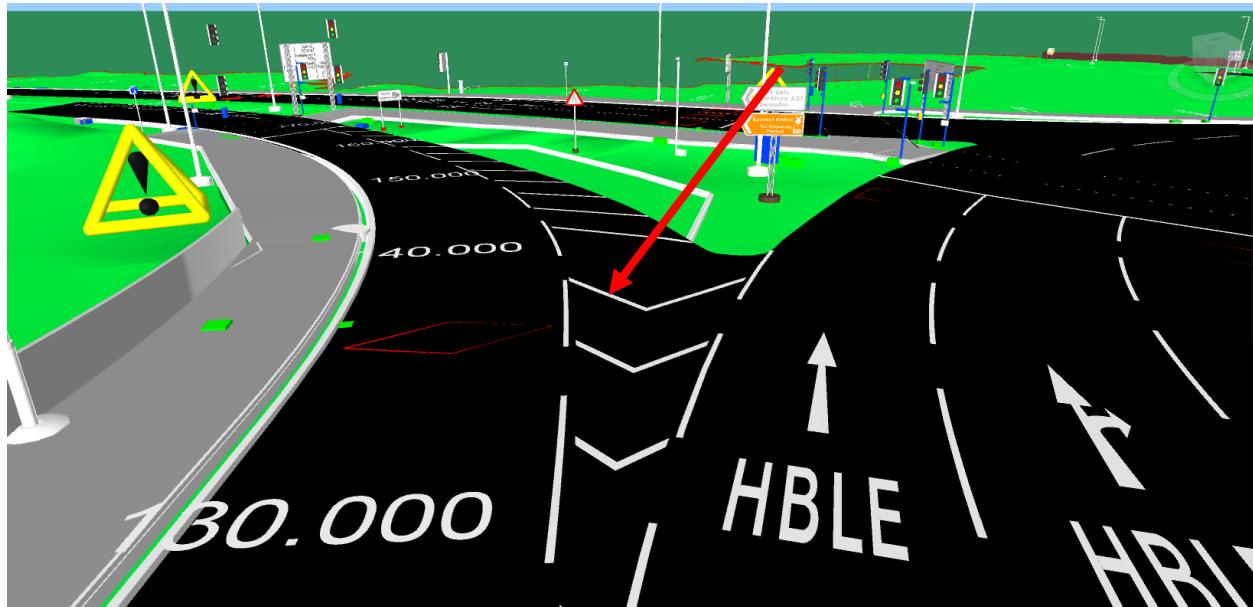
**Figure 4:6 Hatched area of carriageway on the approach to Providence Hill**

The presence of the proposed hatching raises a number of road safety concerns. Firstly, the hatching will introduce an excessive amount of 'dead' carriageway space that in the absence of vehicle runover is likely to collect debris and rubbish that may create a hazard for any vehicle that enters the hatched area, due to reduced skid resistance. Secondly, users of the Toucan crossing may feel confident waiting in the carriageway in the area shielded by the hatching. This may potentially expose users of the Toucan of an increased risk of vehicle strikes and injury if approaching vehicles overrun or utilise the hatched area.

It is recommended that the hatched area is reduced and replaced with an extension to the physical island, (whilst retaining sufficient space to enable the passing of any broken down vehicle at this location). This will provide a shorter crossing distance for vulnerable road users, remove the lack of clarity of the use of the road space, and reduce the necessity for highway sweeping.

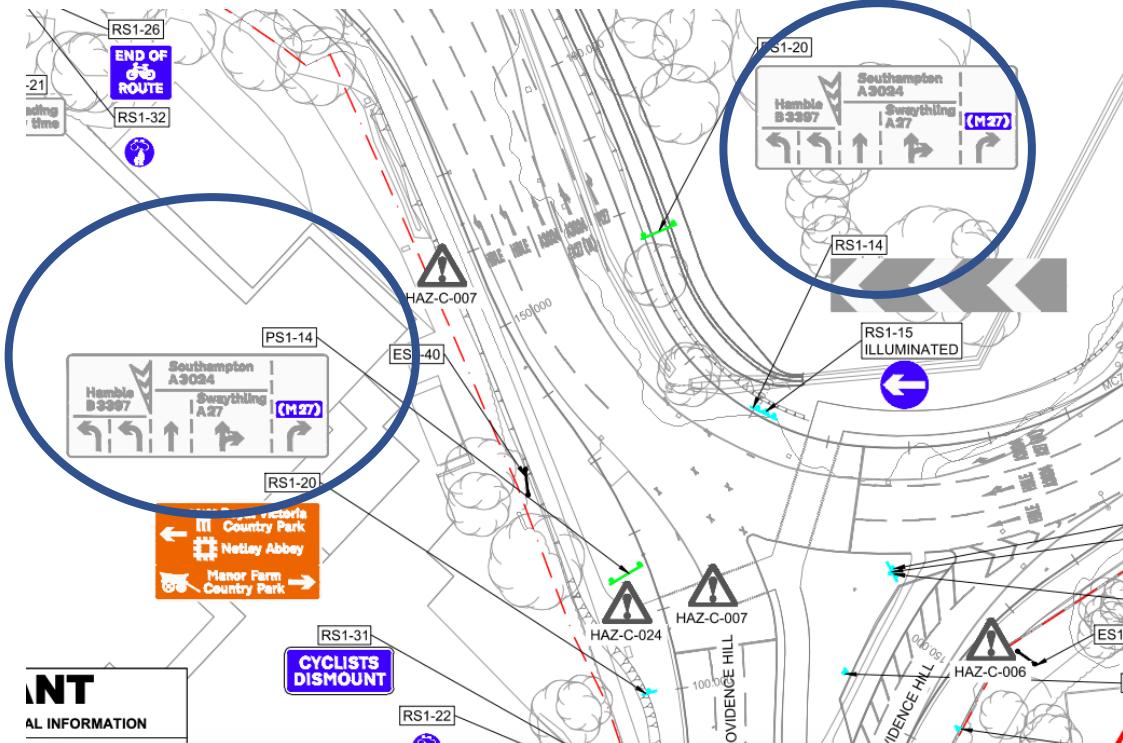
**Figure 4.7: Lane guidance signs on Providence Hill/Windhover Circulatory**

right side of the carriageway where 5 lanes are present there is a concern that vehicles circulating on the left side of the roundabout may fail to see the directional sign, particularly if a high sided vehicle is masking the sign. Unfamiliar drivers may therefore be unclear of the appropriate lane to select for their onward route leading to possible hesitancy and side swipe crashes from late lane changes.

It is recommended that sign reference PS1-14, which provides lane guidance information, is relocated forward of its current position in a north-westerly direction so it is placed alongside the roundabout circulatory where it may be visible to northbound traffic from Providence Hill as well as circulatory traffic.

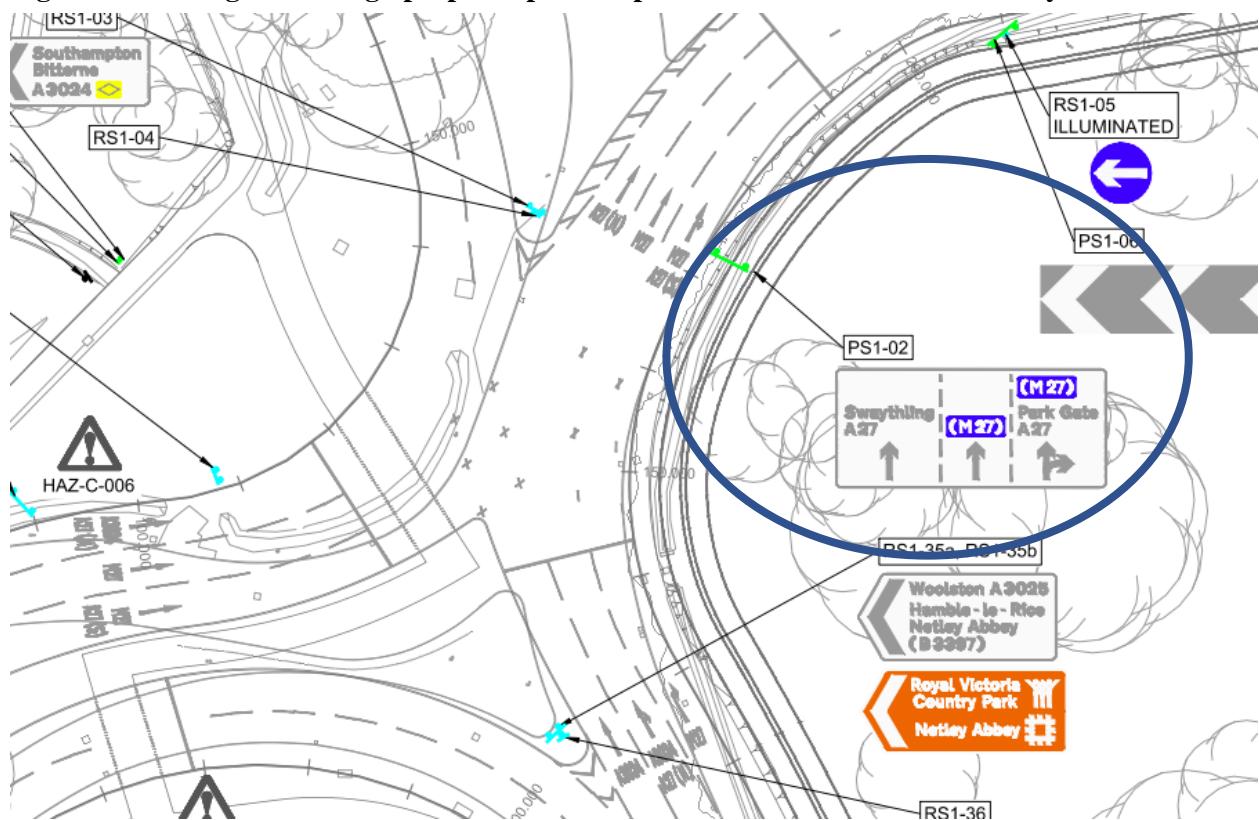
**Figure 4.8: Lane guidance sign proposed position provides limited forward visibility**

It is further noted that at this location, and throughout the circulatory, the vertical road sign provides place name directional finding, i.e A27 Swaythling & A27 Park Gate. In contrast, the carriageway markings indicate A27 (N) and A27 (S). This reflects existing provision, but may not fully inform unfamiliar drivers, adding to potential hesitancy in drivers and subsequent increased likelihood of conflicts.

It is recommended that signage is positioned so that it provides clear advance information to road users. The application of an addition N (north) and S (south) symbol on vertical signage may also aid route finding.

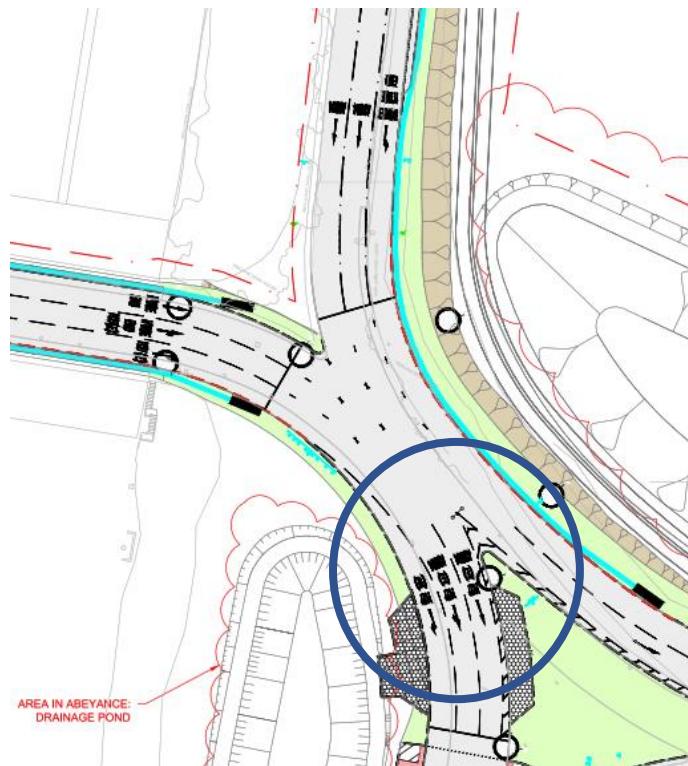
**Figure 4.9: Circulatory carriageway markings**

On the southbound circulatory carriageway the lane allocation markings appear to show both M27 (E) and A3204 traffic using lanes 1 and 2 of the circulatory carriageway. It is acknowledged that these traffic streams are separated within the signal phasing / staging however, in peak traffic periods excessive queuing may mean that these traffic streams are mixed and this may lead to A3204 traffic in lane 1 crossing M27 (E) traffic in lane 2 at the gyratory exit. This may lead to side swipe type collisions.

It is recommended that the circulatory traffic lane allocations are amended to remove the potential conflict. It would appear that the 3<sup>rd</sup> lane allocation for M27 (W) appears to be unnecessary and could be replaced with A3204, which would mean that lane 1 of the circulatory could be marked for M27 (E) only; this would require minor amendments to spiral markings.

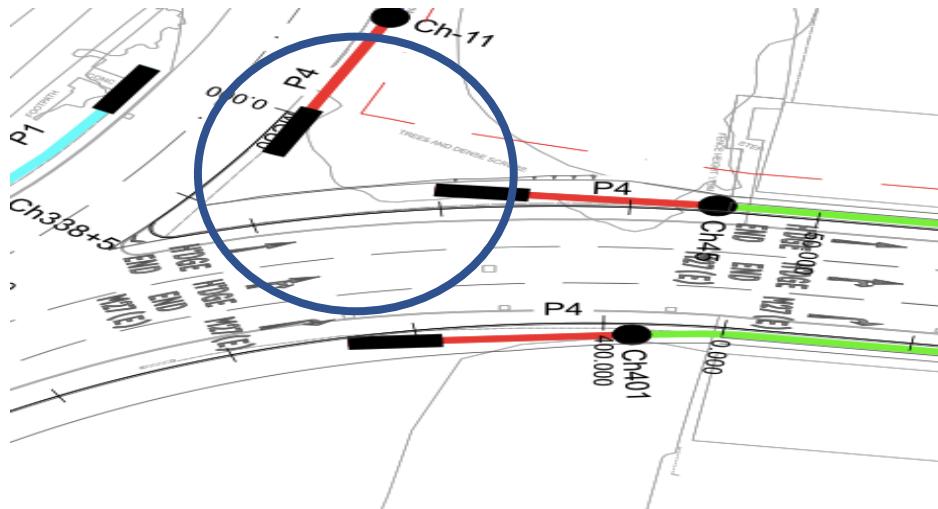
**Figure 4.10: Gap between sections of VRS**

The proposed arrangement for VRS provides a gap between the two sections of VRS which an errant vehicle may enter. The road safety concern is exacerbated as the current situation appears to show that two existing directional signs and a motorway dot matrix sign is provided at this location and will appear to be unprotected by the new arrangement. Note: the sign drawing indicates sign reference ES3-07 only at this location, and this sign is not listed in the provided schedule, so sign information and post detail is not known.

It is recommended that roadside furniture is adequately protected by VRS, alternatively passively safe posts are introduced.

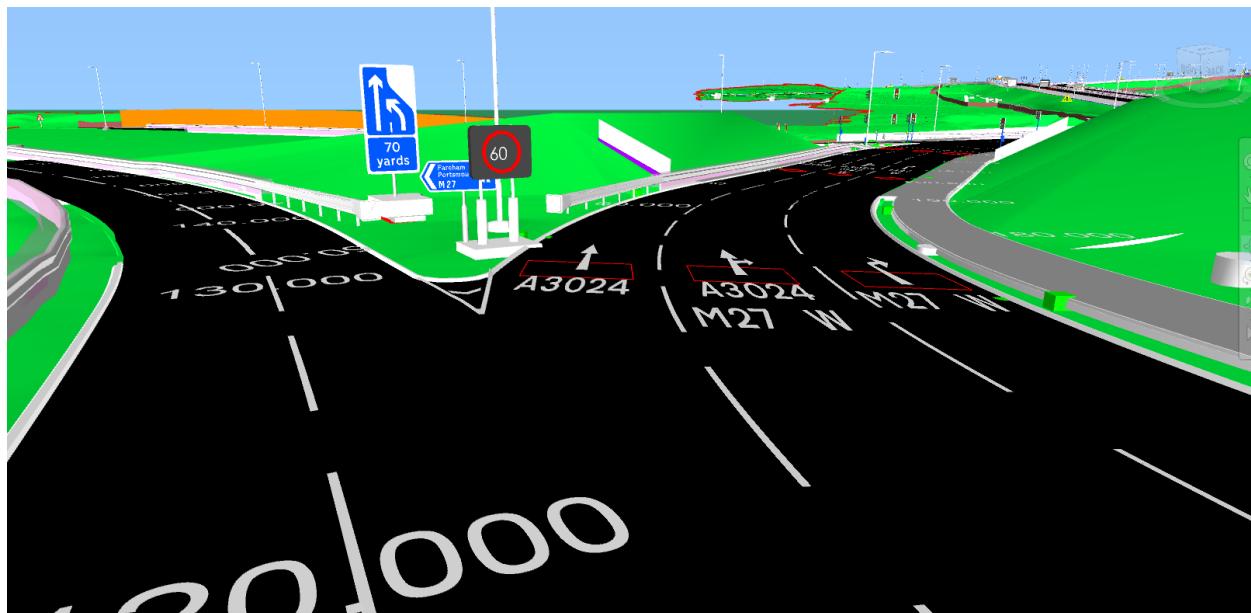
**Figure 4.12: Unprotected roadside furniture on the nosing of the M27 Eastbound entry slip Junction 8**

The proposed arrangement for VRS provides a gap between the two sections of VRS which an errant vehicle may enter. The road safety concern is exacerbated as the current situation shows numerous signs located within the nosing area (including some new posts currently under placement as part of the on-going M27 smart motorway project). Note: the sign drawing indicates sign reference PS3-12 introduced at this location as part of the works, which is positioned on a small diameter post. Details of other signs is not known.

It is recommended that roadside furniture is adequately protected by VRS; alternatively passively safe posts are introduced.

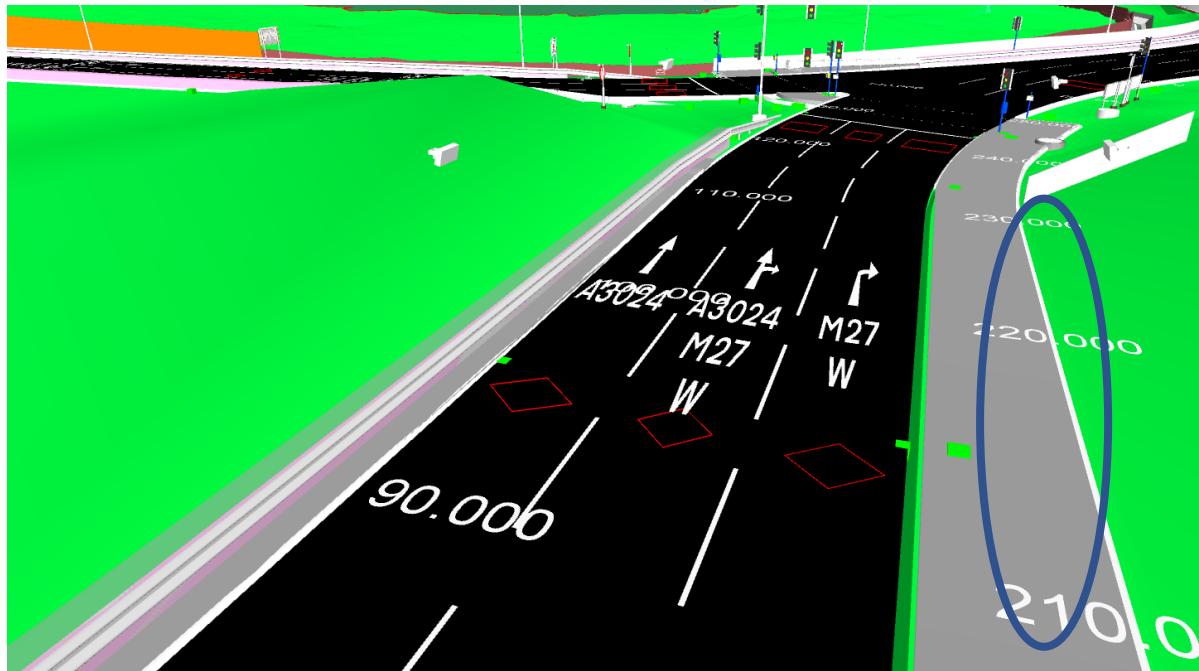
**Figure 4.13: Highlighted section where VRS is removed on the M27 J8 circulatory.**

On the southern side of the roundabout circulatory of the M27 junction 8 roundabout, the existing vehicle restraint system is being removed from the inner side of the circulatory area, as highlighted in Figure 4.13. The existing restraint system currently offers protection to the bridge piers which support the M27 over the roundabout. The restraint system proposed to be removed from this location will be replaced with a High Containment Safety Kerb which is designed to allow the introduction of a shared cycle/pedestrian route. There is a concern that an errant vehicle at this location which strikes the High Containment Safety Kerb (which is proposed to replace the VRS at this location) may be launched and this in turn may result in the vehicle striking a pedestrian/cyclist utilising the shared route, or/and a direct strike on the bridge piers which may result in potential bridge collapse.

It is recommended that a vehicle restraint system is retained at this location to support the bridge piers.

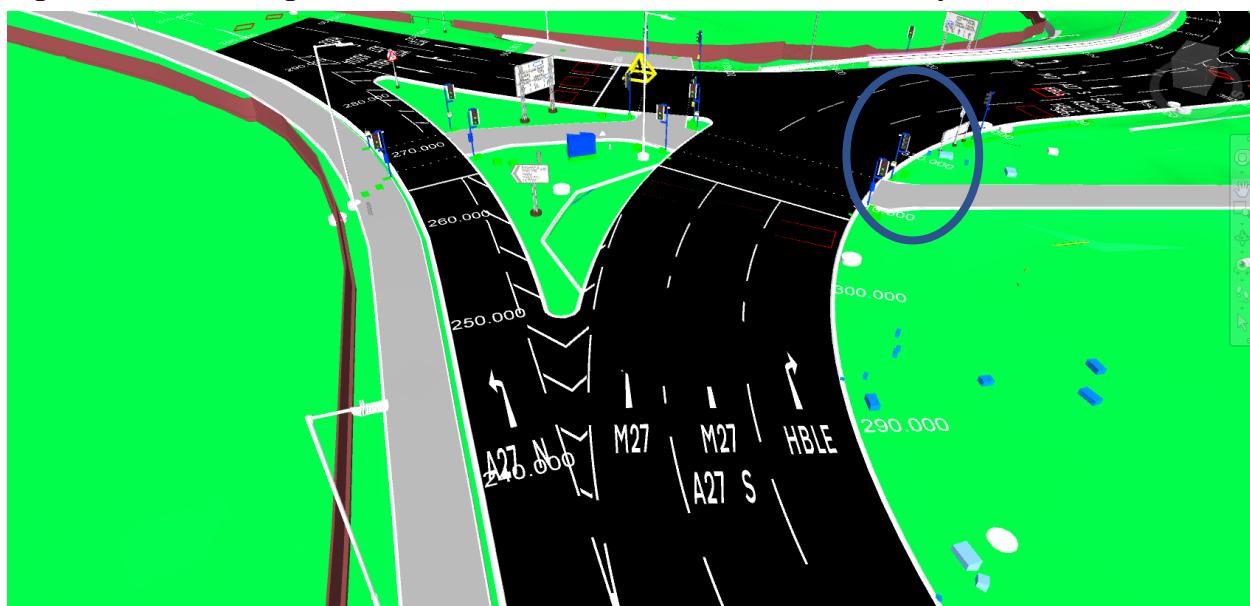
**Figure 4:14: Traffic signal heads on the Windhover roundabout circulatory near West End Road.**

The Windhover roundabout circulatory includes a section of carriageway where the proposed traffic signal heads controlling the West End Road arm are located on the roundabout circulatory radius as shown in Figure 4.14. There is a danger therefore that the traffic signal heads are not clearly visible to circulating vehicles, particularly if the visibility to the traffic signal head on the nearside of the carriageway is masked by a stationary high sided vehicle. This may result in a circulating vehicle in lane 2 or lane 3 failing to note the traffic signals sufficiently enough in advance, therefore resulting in potential overshoot type crashes and conflicts with crossing vulnerable road users, or potential rear shunt type crashes with queuing vehicles.

It is recommended that a high signal head is provided at this location to help provide advanced information to approaching vehicles of the traffic light status ahead.

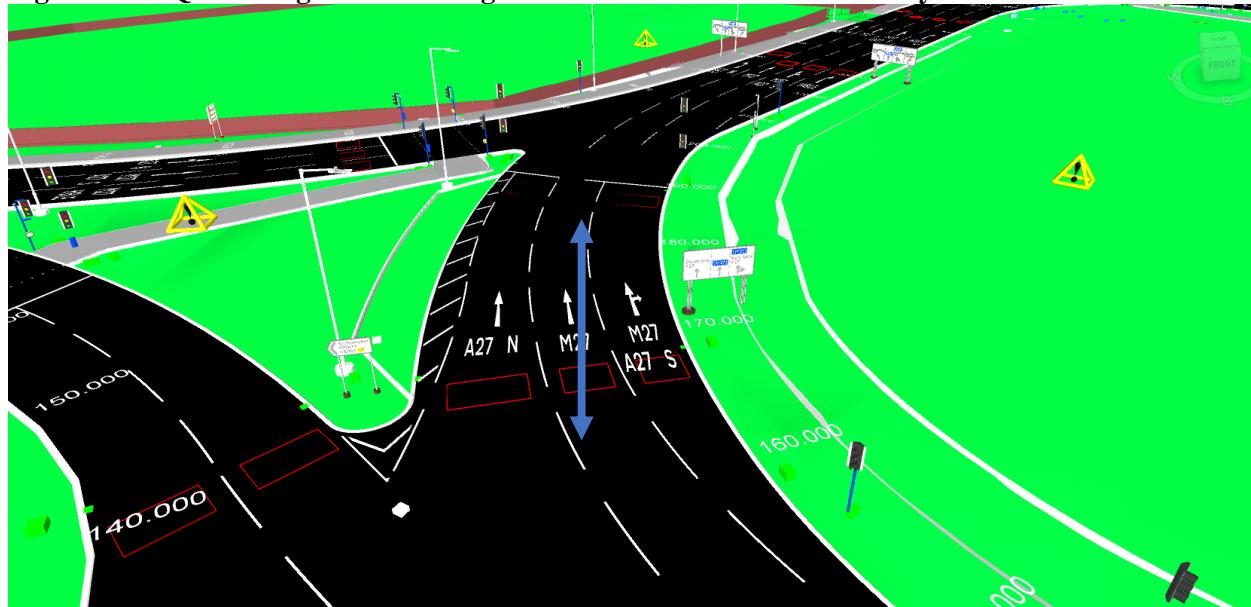
**Figure 4:15: Queue length at traffic signals on Windhover Rbt circulatory near Hamble Lane**

The presence of a limited stacking capacity may result in an increased likelihood of queueing vehicles exceeding the available queuing space and therefore potentially blocking the entry to the roundabout circulatory from Hamble Lane. This may result in driver frustration and an increased likelihood of conflicts.

It is recommended that a yellow box junction is provided at this location noting that the application of the recommended spiral road markings raised earlier within this Road Safety Audit report at this location may result in excessive carriageway markings which may compromise conspicuity.

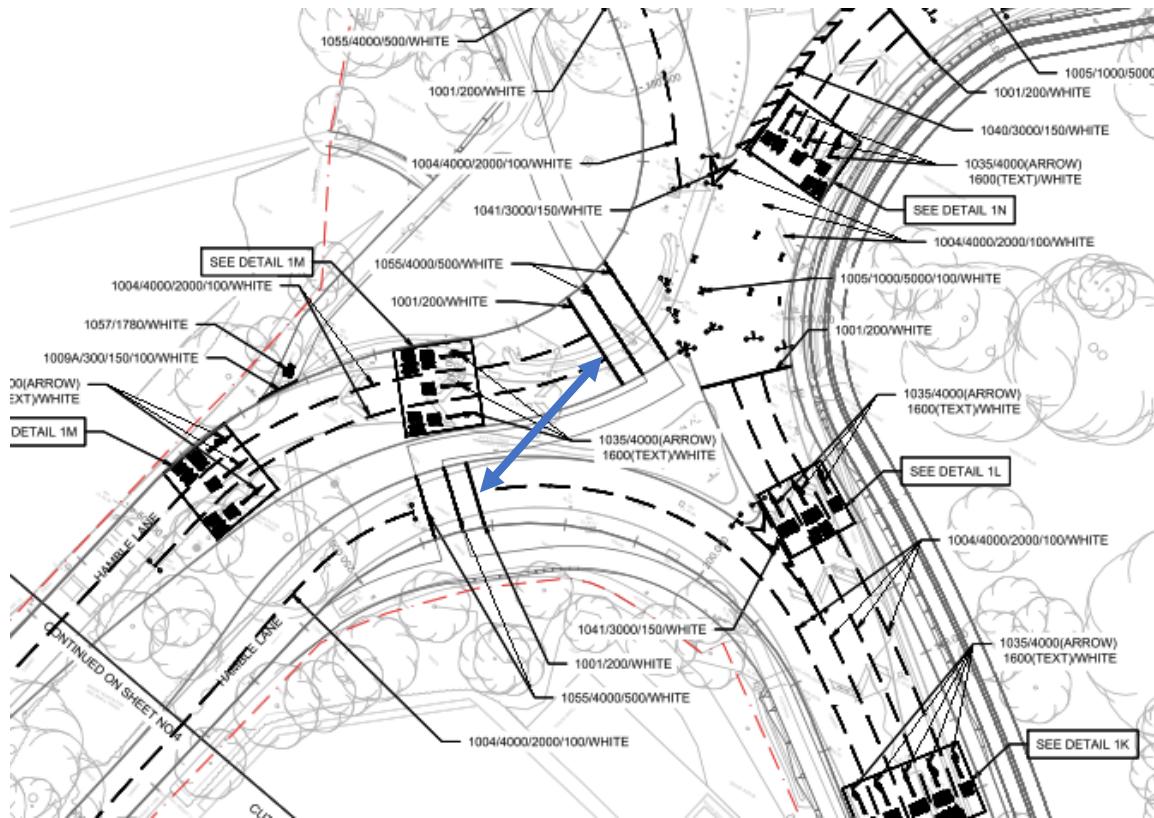
**Figure 4.16: Toucan crossings over Hamble Lane**

It is also noted at this location that there is a height difference between the east and westbound carriageway. The amendments to the infrastructure for vulnerable road users at this location may result in the introduction of a shared footway with a gradient which may result in an increased likelihood of slips for users, particularly when the surface is wet/icy, therefore increasing the likelihood of falls.

The Toucan crossing on Hamble Lane westbound carriageway is relocated further to the east on Hamble Lane. This also provides improved visibility for vehicles turning into Hamble Lane towards any users of the Toucan crossing. The shared footway shall include an appropriate grade to ensure the facility is comfortable to users with the likelihood of slips minimised.

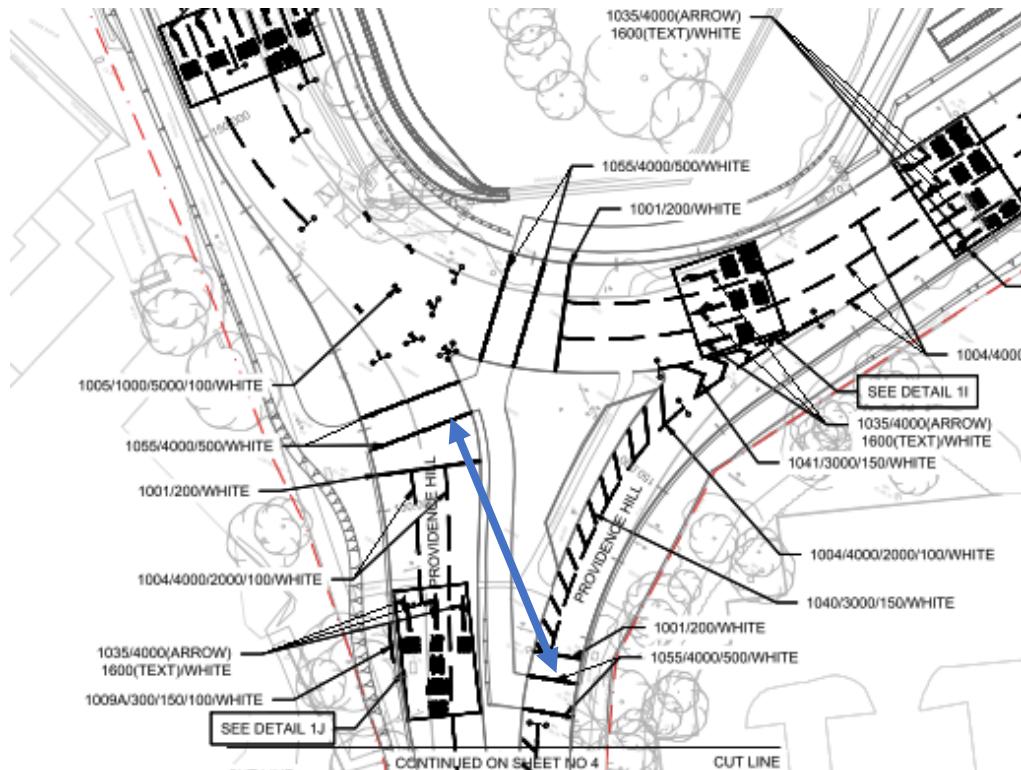
**Figure 4.17: Toucan crossings over Providence Hill**

The proposed Toucan crossing over Providence Hill between north and southbound carriageways include a stagger within the central island between the two carriageway directions. This results in users heading between the east and west directions having to divert from the natural 'straight ahead' desire line to utilise the Toucan for each carriageway approach. This may result in some users avoiding the use of both of the Toucan crossings at this location, and instead crossing without signal control, thereby avoiding the need to divert from their assumed natural desire line. Crossing without the aid of signal control may increase the likelihood of vehicle strikes.

The Toucan crossing on Providence Hill is repositioned to reduce the proposed stagger distance. The repositioning of the southbound carriageway Toucan further to the north towards the roundabout circulatory may result in improved forward visibility towards the traffic signals which in turn may be beneficial in terms of road safety.

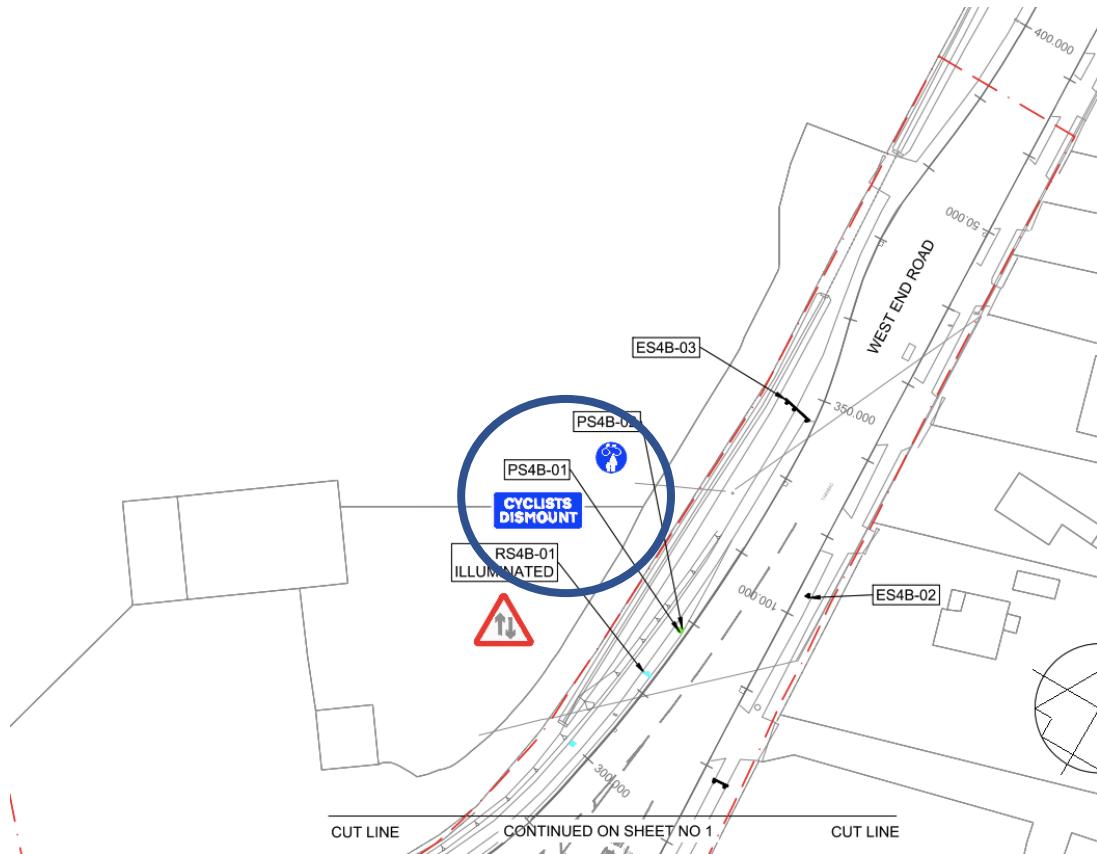
**Figure 4.18: Signage to cyclists at the end of the shared use footway.**

Cyclists heading northbound on the shared used footway on the westside of West End Road reach the end of the shared use facility and are confronted with a sign requesting cyclists to dismount. This does not provide clear information on how cyclists may continue their journey northbound in a safe manner thereby reducing the likelihood of conflict with other road users.

It is recommended that the proposed 'Cyclists Dismount' signage is removed and instead information is provided to direct cyclists safely back to the carriageway; a dropped kerb return to the carriageway may be appropriate for cyclists.

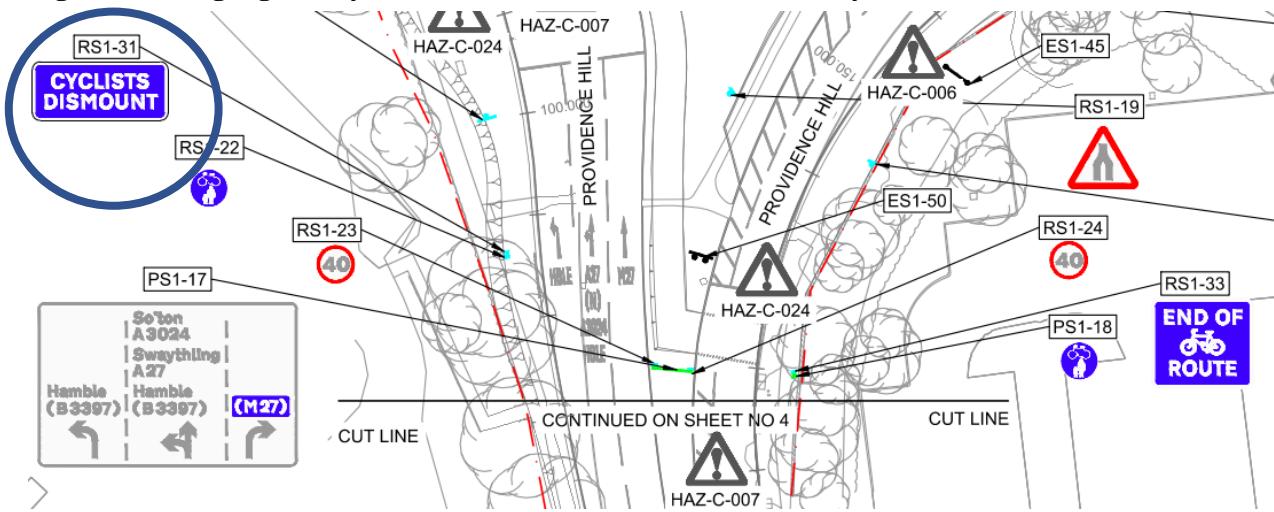
**Figure 4.19: Signage for cyclists on the southbound shared footway.**

For cyclists heading southbound on the shared cycle facility on the westside of Providence Hill, there is no onward wayfinding information provided to users. Instead, a proposed sign instructing cyclists to dismount is included. This may result in confusion for cyclists unfamiliar with the location and may result in a lack of clarity on which onward route to select. Uncertainty on the correct onward route may result in confusion and the increased potential for conflicts.

It is recommended that continuous and coherent cycle facilities are provided and the proposed 'Cyclists Dismount' and 'End of Route' signage are removed and appropriate information is provided to direct cyclists safely back to the carriageway.
