APPENDICES

(i) Consultation with Historic England

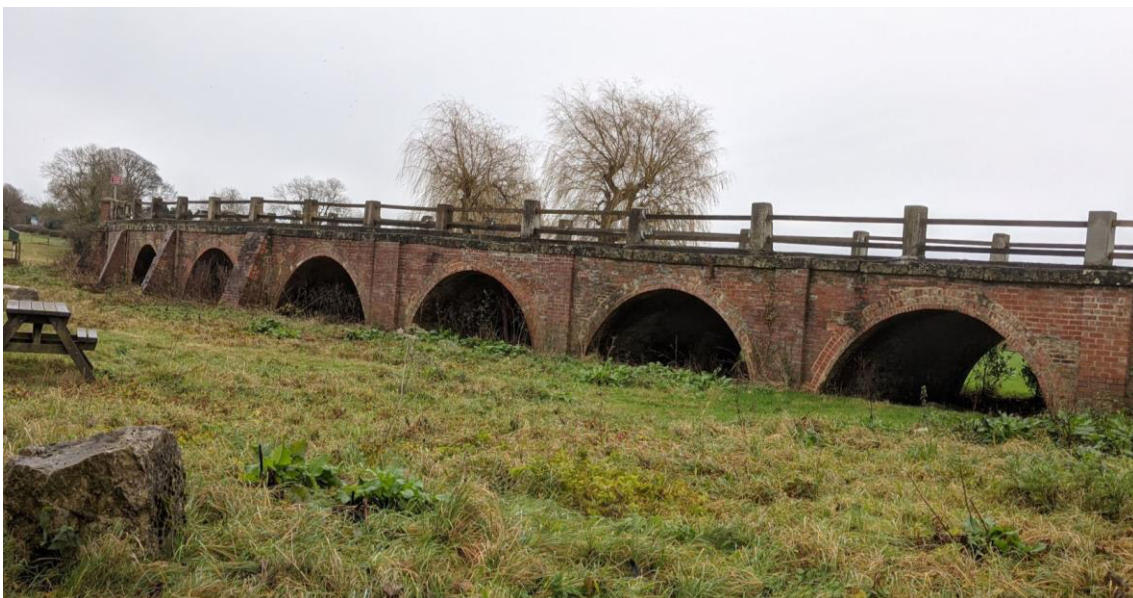
Figure 1: The 18C brick flood arches of the West approach with the 20C concrete posts and timber rails to the upstands, built in a curved line.

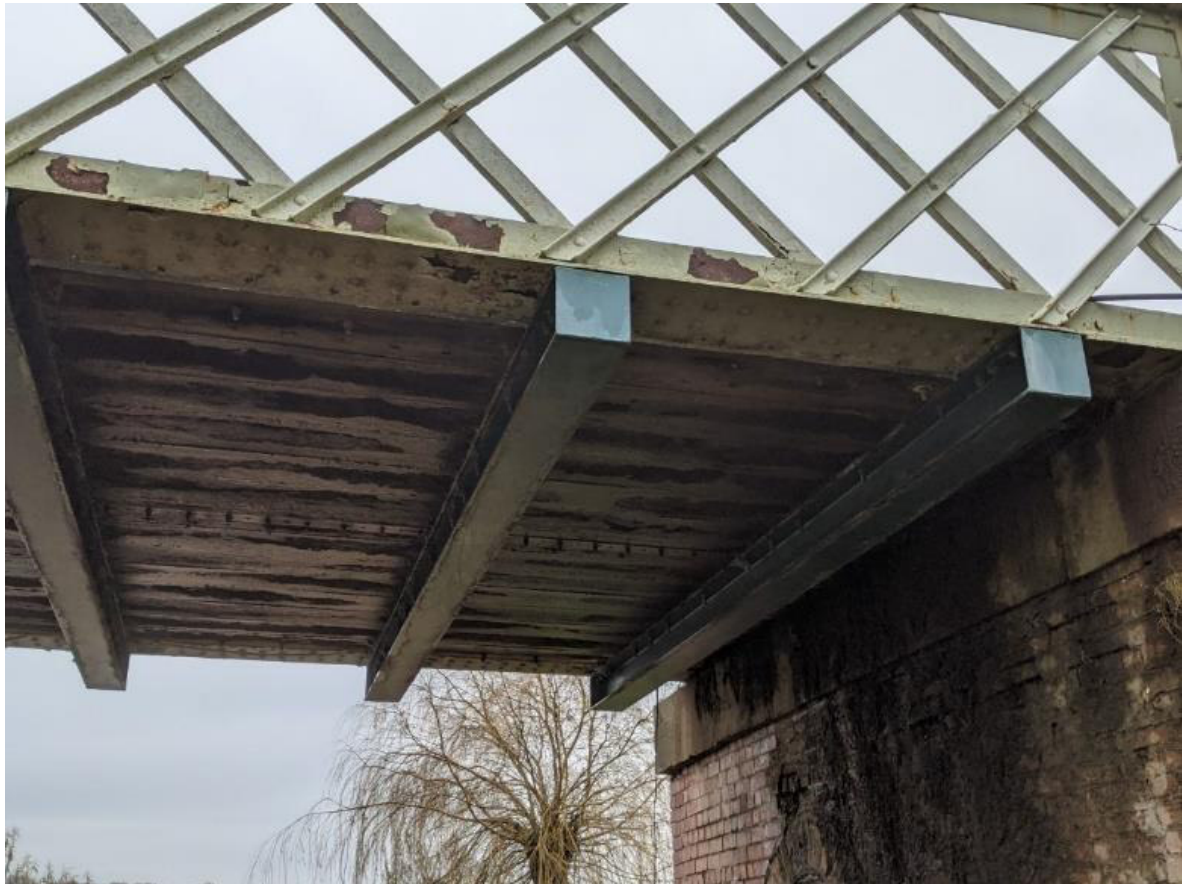
Figure 4: The two main horizontal beams spanning the river are interconnected with cross beams underneath, now replaced with new sections in steel.

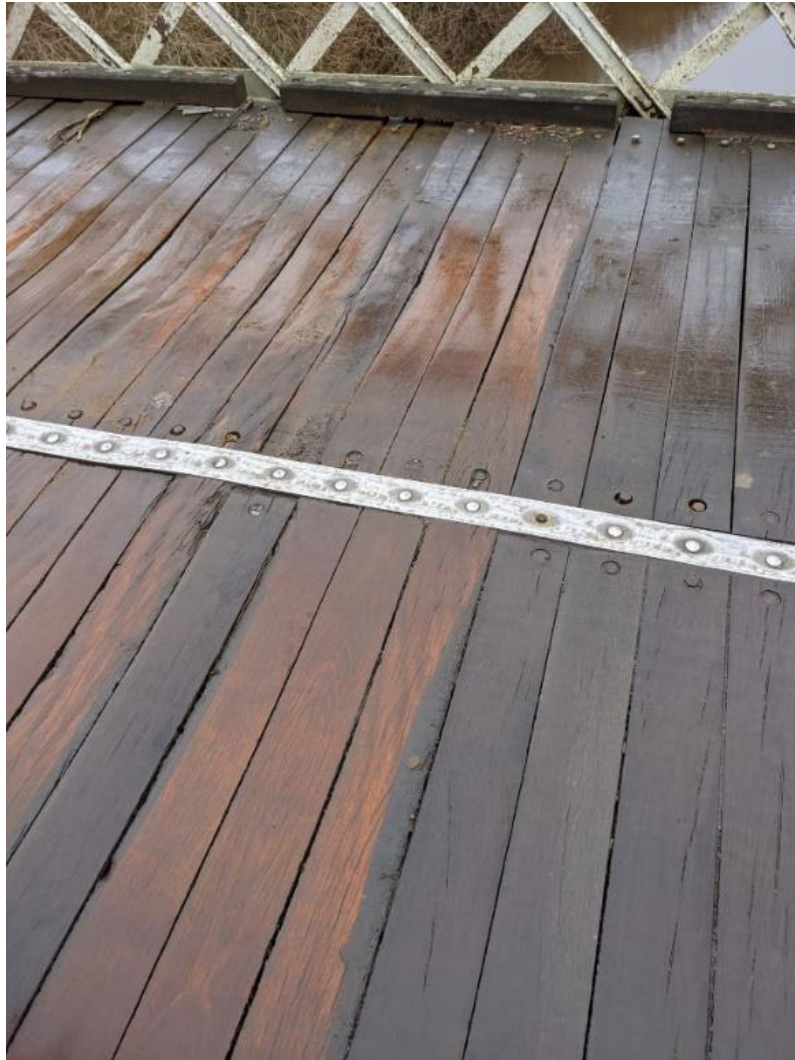
Figure 5: The top decking is demarcated by a double row of bolts holding down the inner ends of the boards, the one row further aligned with a steel strap.

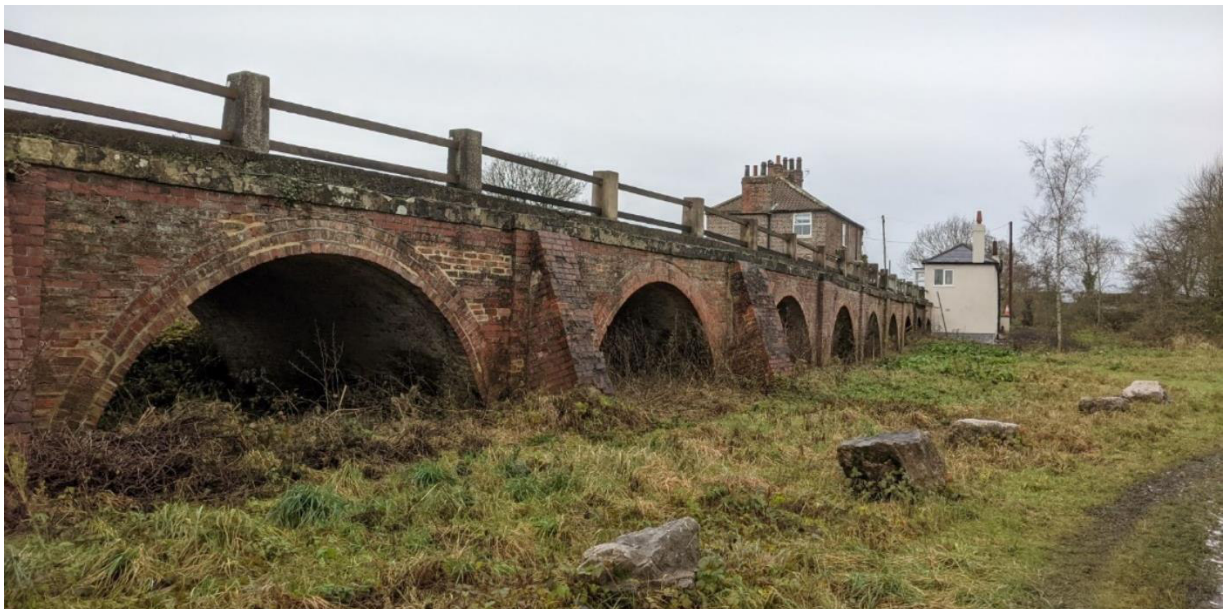
Figure 9: North view of the West approach of the bridge with the toll house on right and the red brick house on left demarcating its beginning.

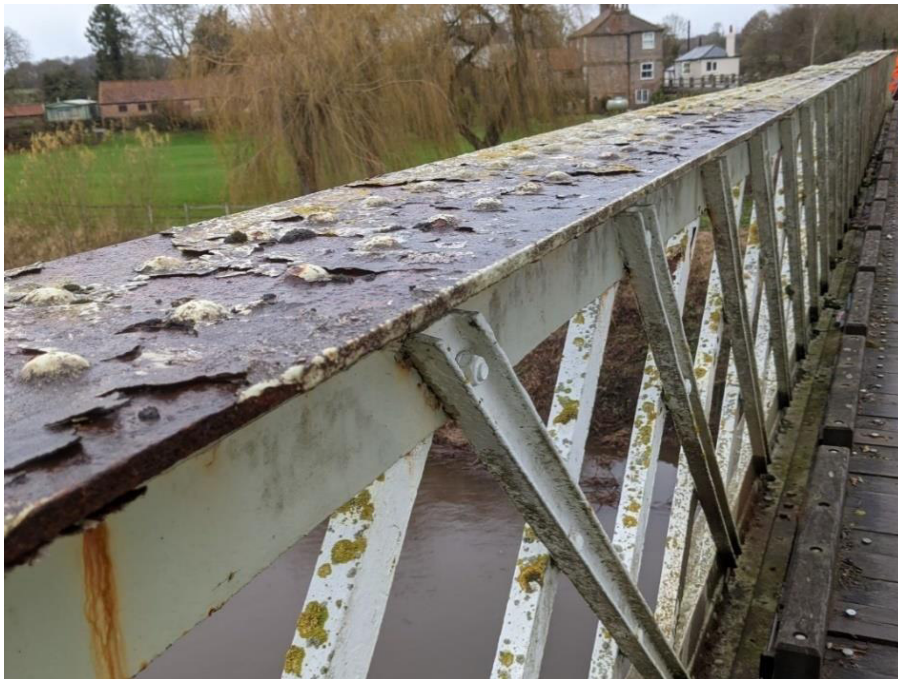
Figure 10: Protective coatings to metalwork are damaged and flaking leaving the metal surface vulnerable to corrosion. This is particularly evident at the top surfaces of the parapets.

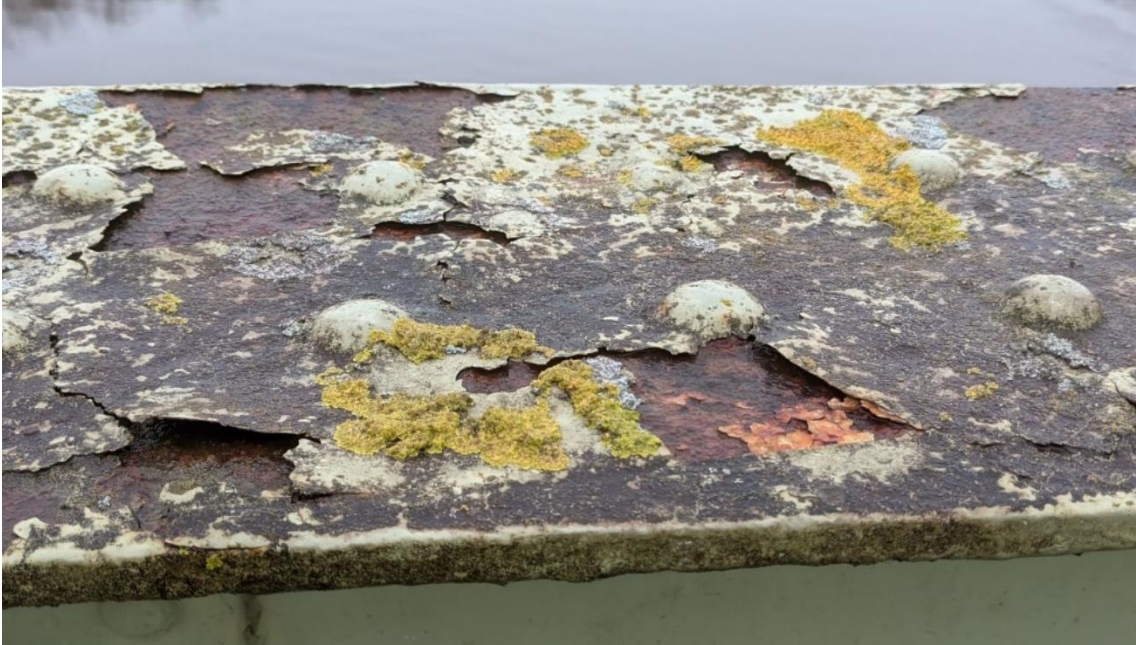
Figure 11: Close up of the damaged coating at the top surface of the parapet with corrosion taking place underneath the protective coating and lichen growth being encouraged.

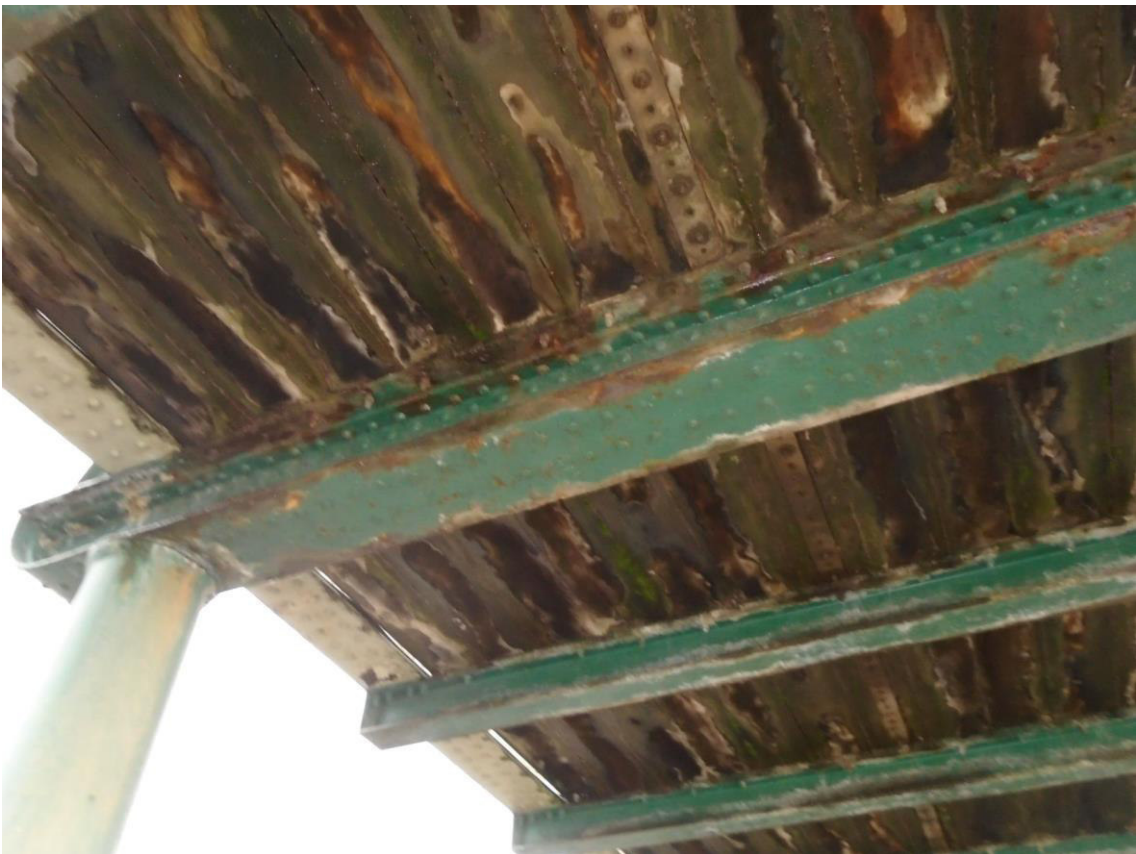
Figure 12: Corrosion has taken place to a significant degree to the cross beams below the timber decking.

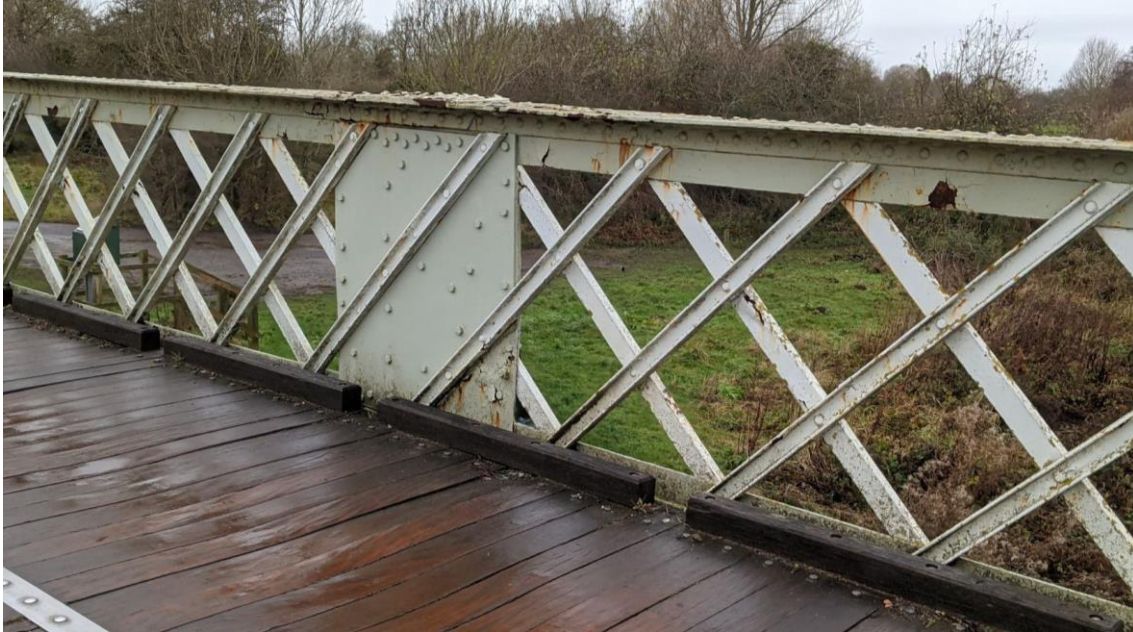
Figure 13: Deterioration extends to more protected elements which are stained with dirt and lichen growth, which will eventually affect the coating which will deteriorate further.

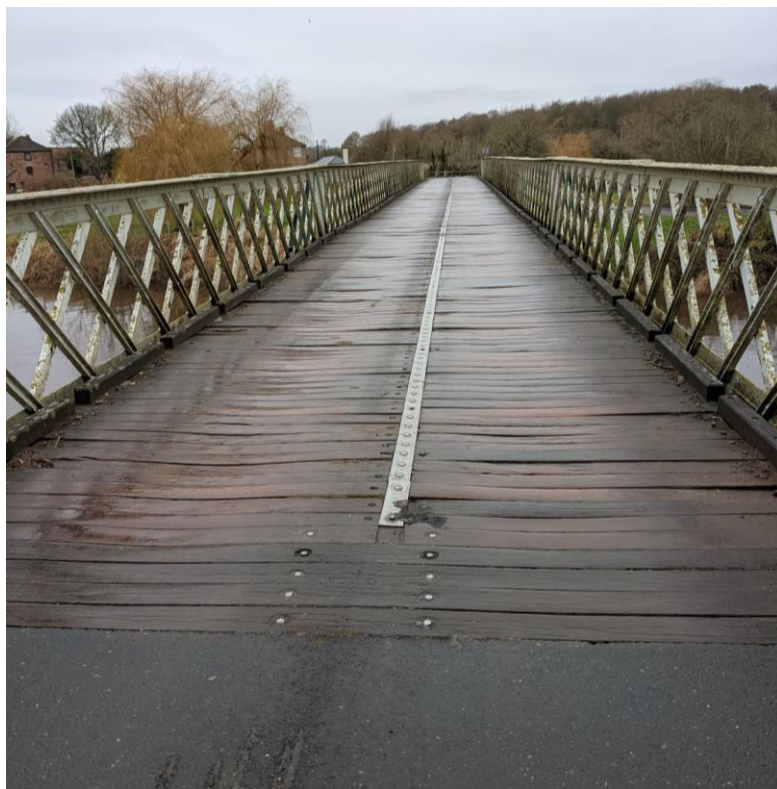
Figure 14: The top decking as viewed from the east approach. The uneven surface is evident with boards having sunk and others projecting.

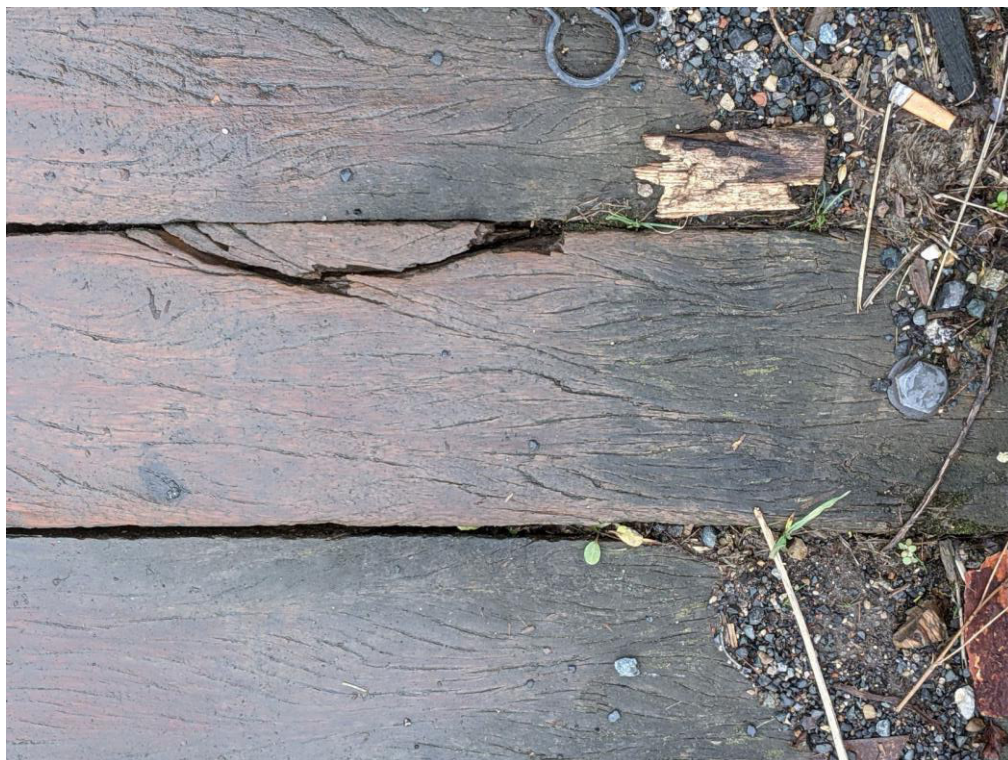
Figure 15: Timber boards with broken pieces and debris around, encouraaina veetation growth..

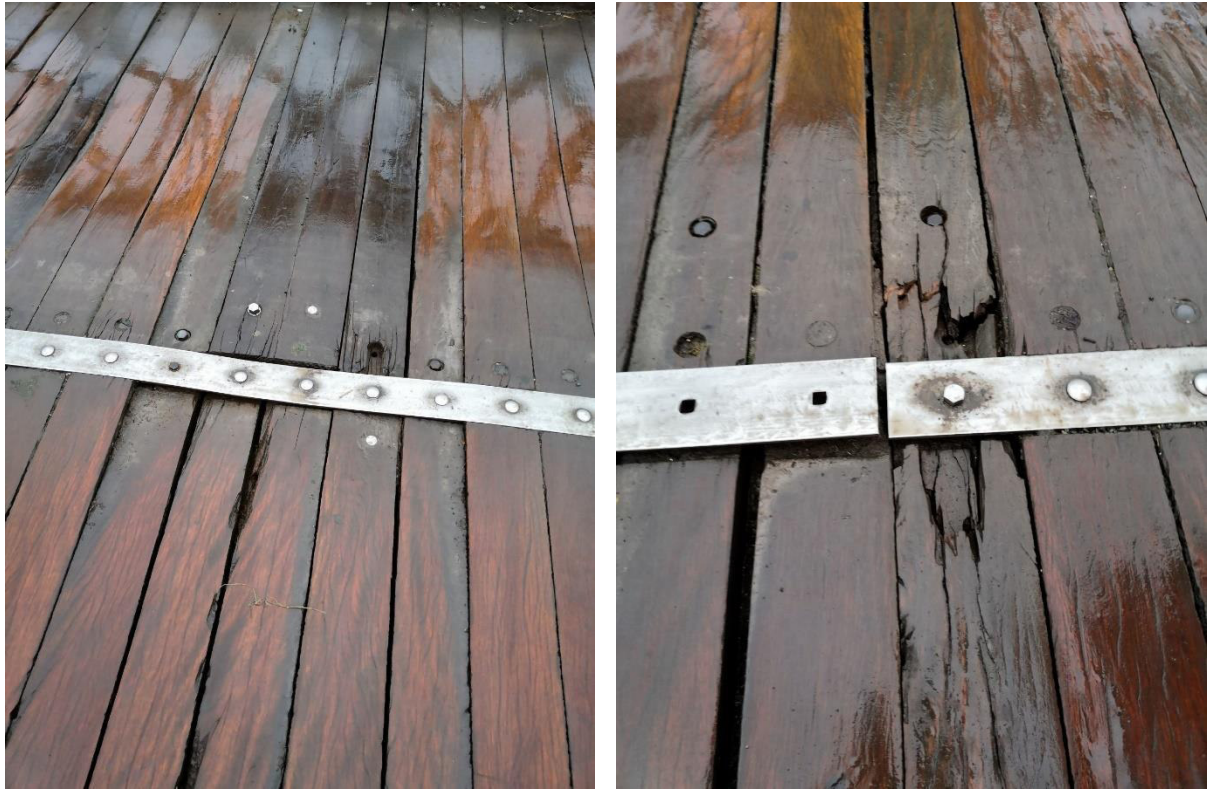
Figure 16, 17: Fixings of the boards are inconsistent in type and location. Others have become loose or lost. The galvanised steel strap has detached and boards have sunk, split and or/moved.

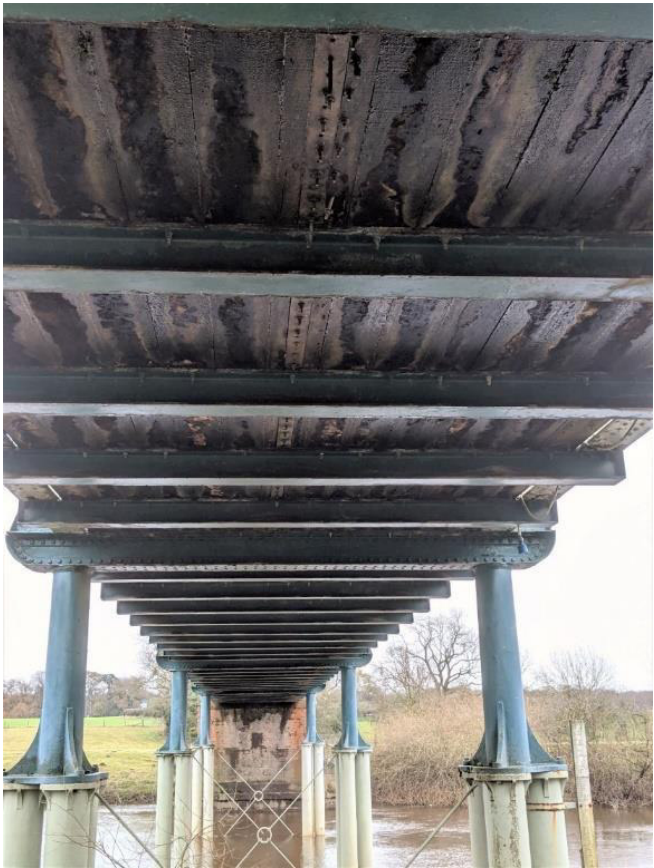
Figure 18: The bottom layer of the decking is extensively stained due to the general wet conditions and the inadequate drainage.
