M27 Southampton Junction 8  
Highways England  
Stage 2 Road Safety Audit

Document reference: HE551514-SWE-HGN-  
ZZ-RP-ZZ-50001

## Report Title                    Stage 2 Road Safety Audit

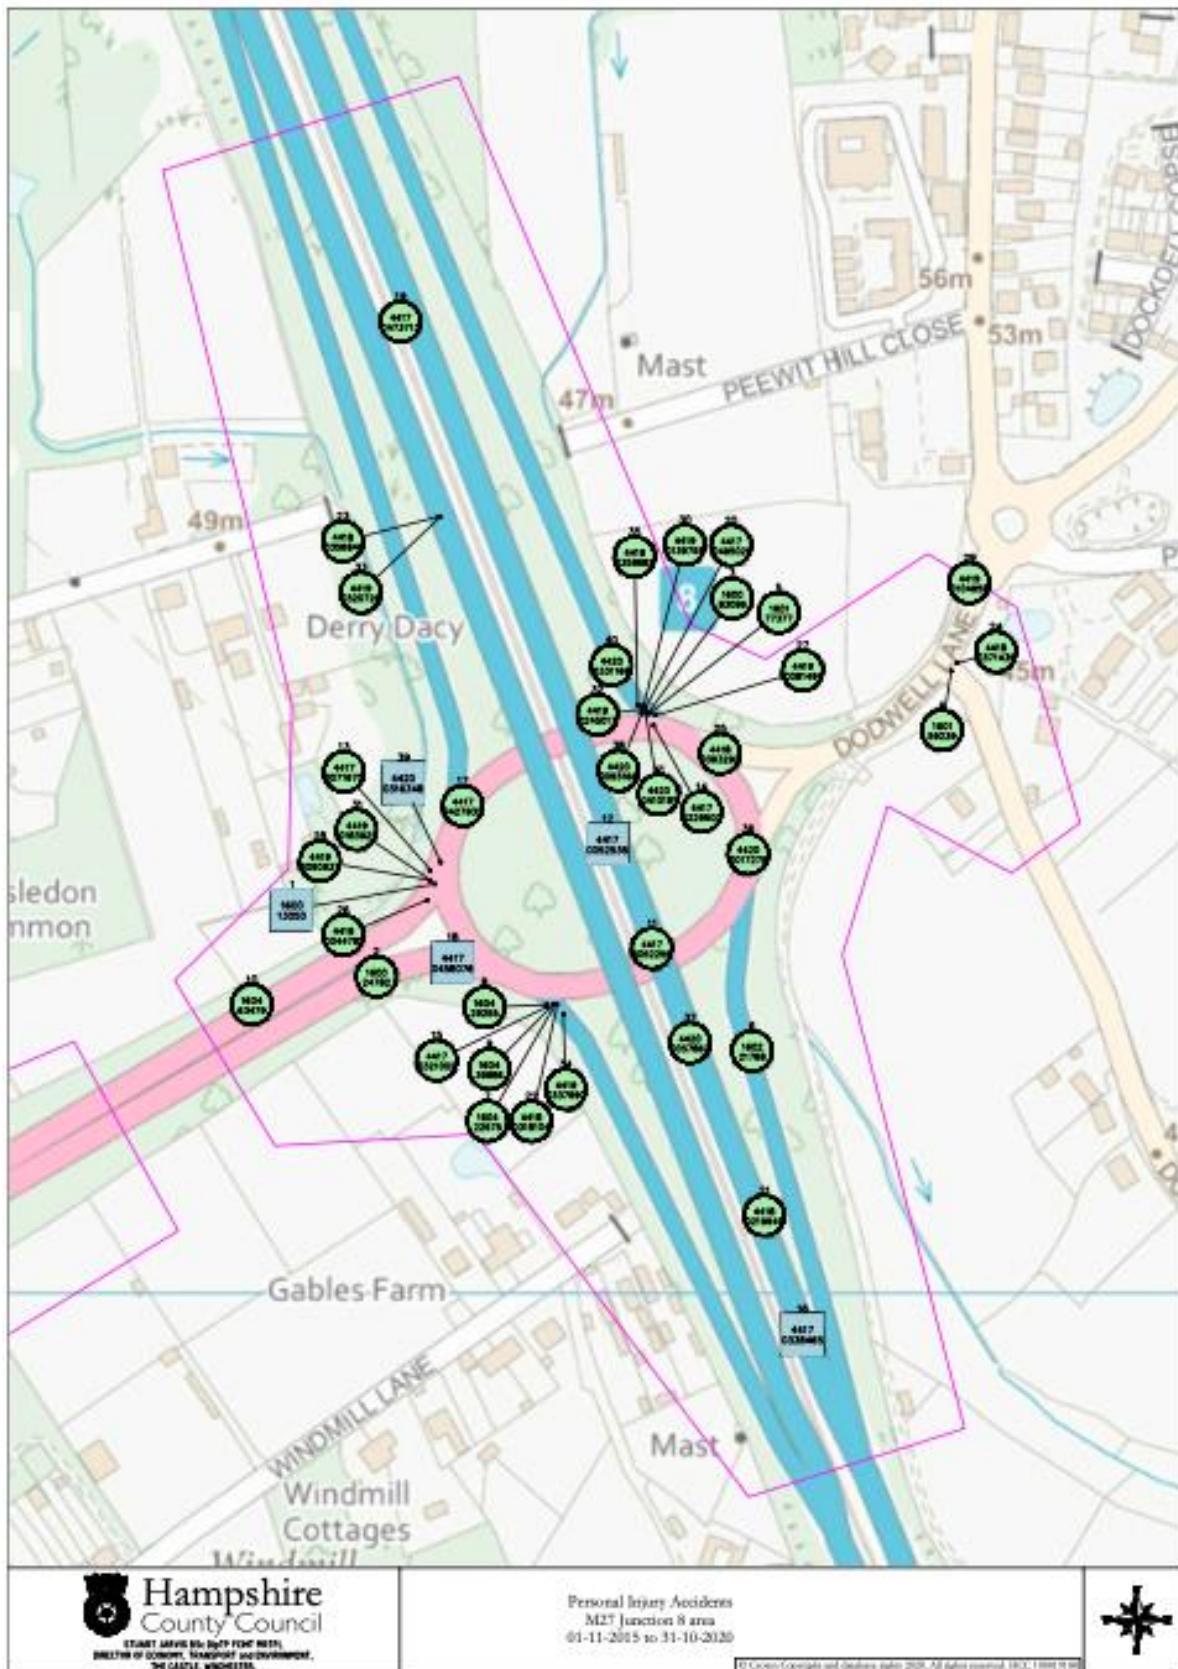
Figure 1.1: Plot of crashes 2015-2020 M27 Junction

A brief summary of the crash history at Junction 8 M27, indicates that the majority of the crashes have occurred on the M27 southbound off-slip on the approach to the roundabout circulatory with 11 crashes recorded at this location over 5 years out of a total 41. Other approaches to the roundabout at junction 8 also included a high cluster of crashes with 7 crashes on the eastbound approach to the M27 junction 8 roundabout from Bert Betts Way, including two serious crashes. On the north bound off slip on the approach to the roundabout circulatory there were 6 crashes.

Overall at junction 8, 30 of the crashes were described as rear shunt type crashes, therefore representing 73% of the crashes at this location. There were no crashes involving cyclists or pedestrians at this location, although there were 8 motorcycles recorded in the crash data.

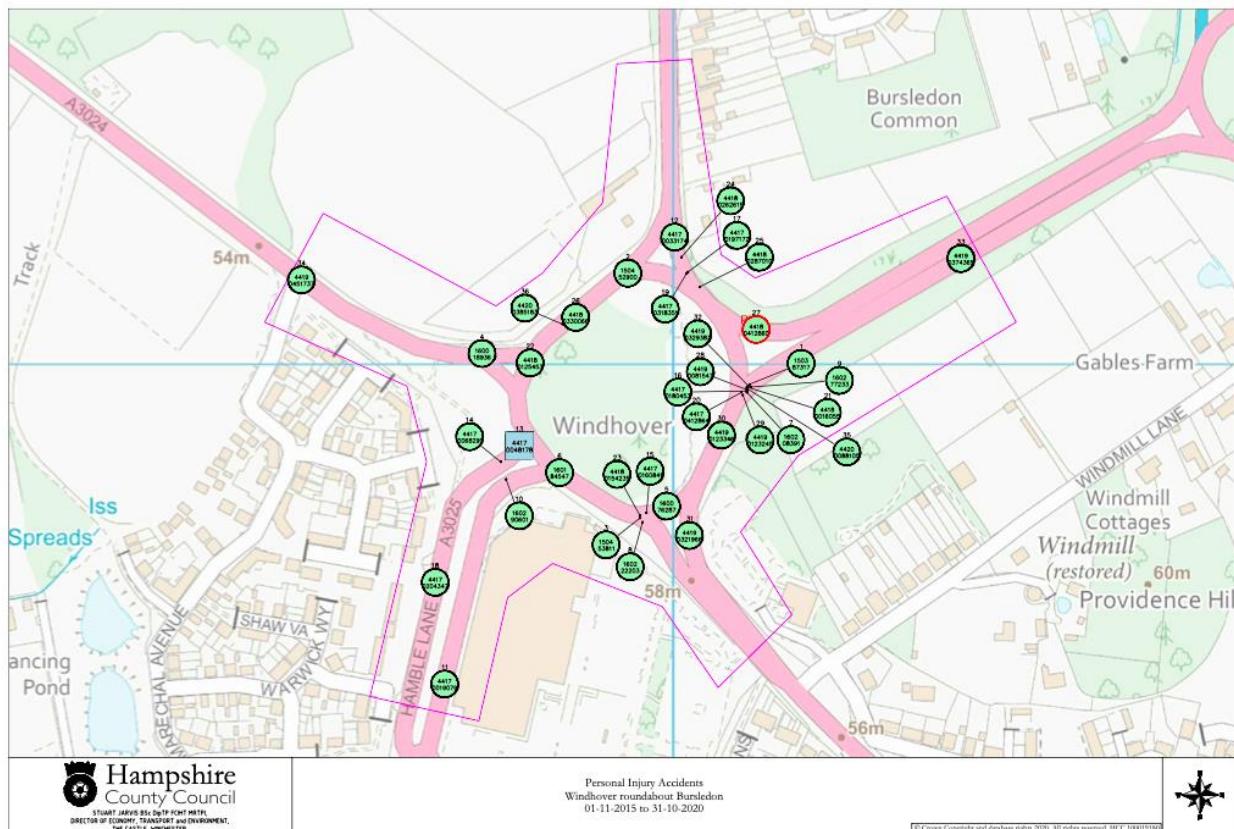
**Figure 1.2: Plot of crashes 2015-2020 Windover Roundabout**

At Windover roundabout and the junction approaches there has been 36 serious and slight injury crashes recorded during the 5 years of data analysed between 2015-2020. No fatal crashes were recorded. The crash data severity by year is shown in Table 1.2. The crash data locations are plotted in Figure 1.2.

It should be noted that the number and severity of crashes reported in 2020 may be unreflective of previous years and trends because of changes in travel patterns in 2020 where government advice due to COVID, instructed people to stay at home, therefore resulting in a significant reduction in vehicle based journeys.
